TECHNICAL REPORT NO. LWL-CR-06C66A

AIRCRAFT MOUNTED PERSONNEL DETECTOR CHEMICAL

Final Phase IV Report
Contract No. DA-18-001-AMC-983(X)

By
Ordnance Systems
General Electric Company
Pittsfield, Massachusetts 01201

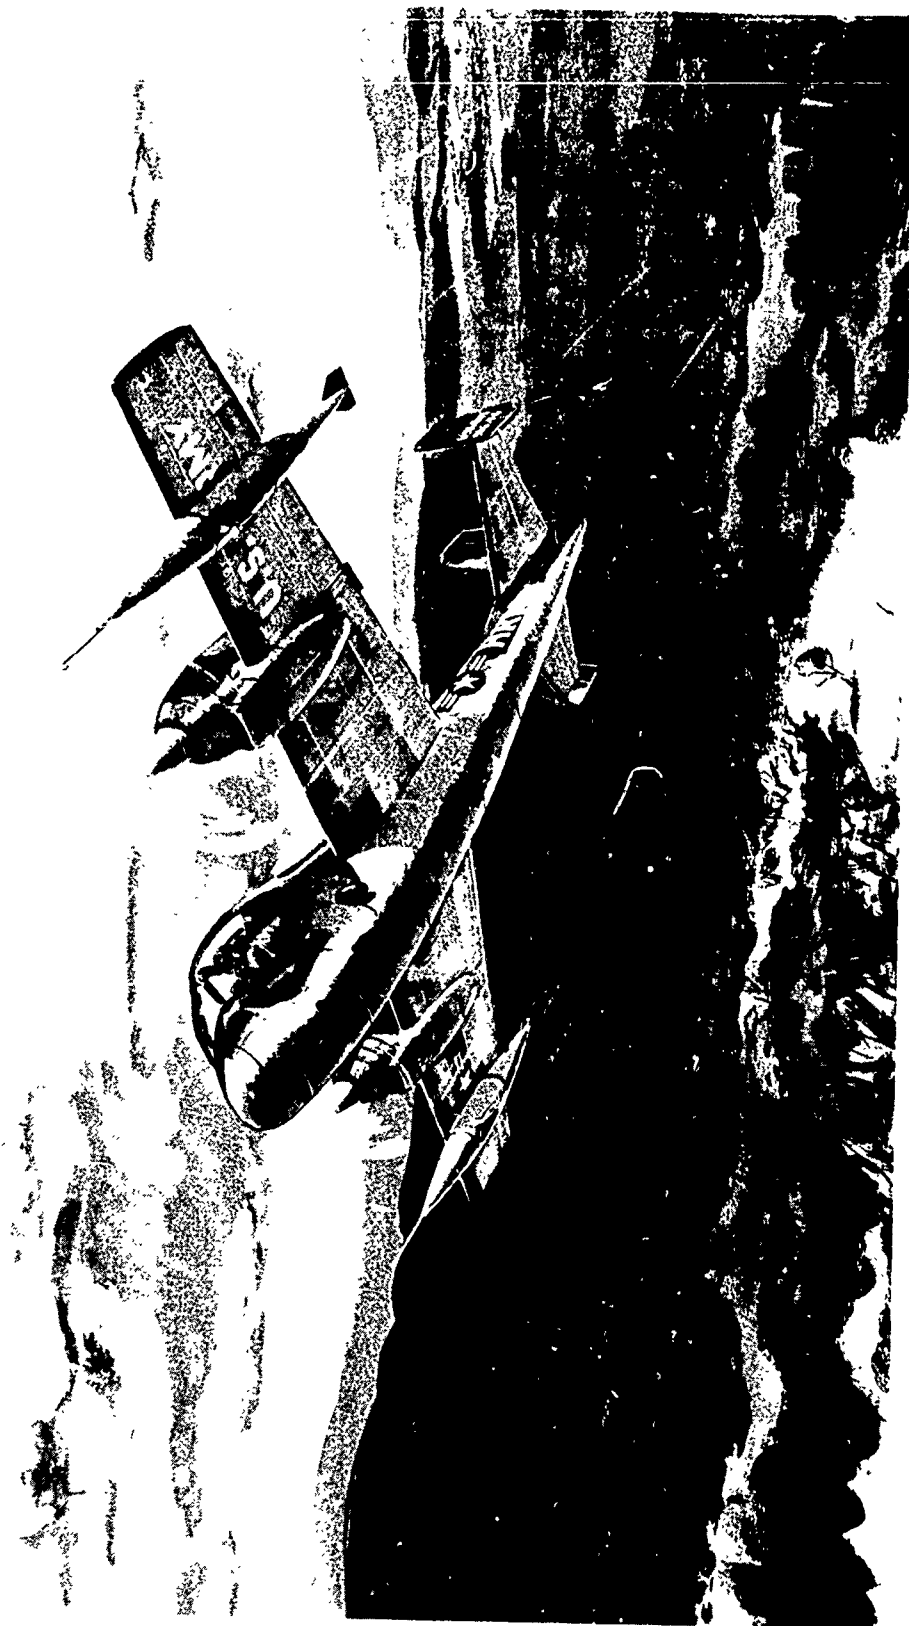
Frontispiece. AMPD-224 Phase IV System (Mounted in Fuel Pods) on JOV1-B Aircraft

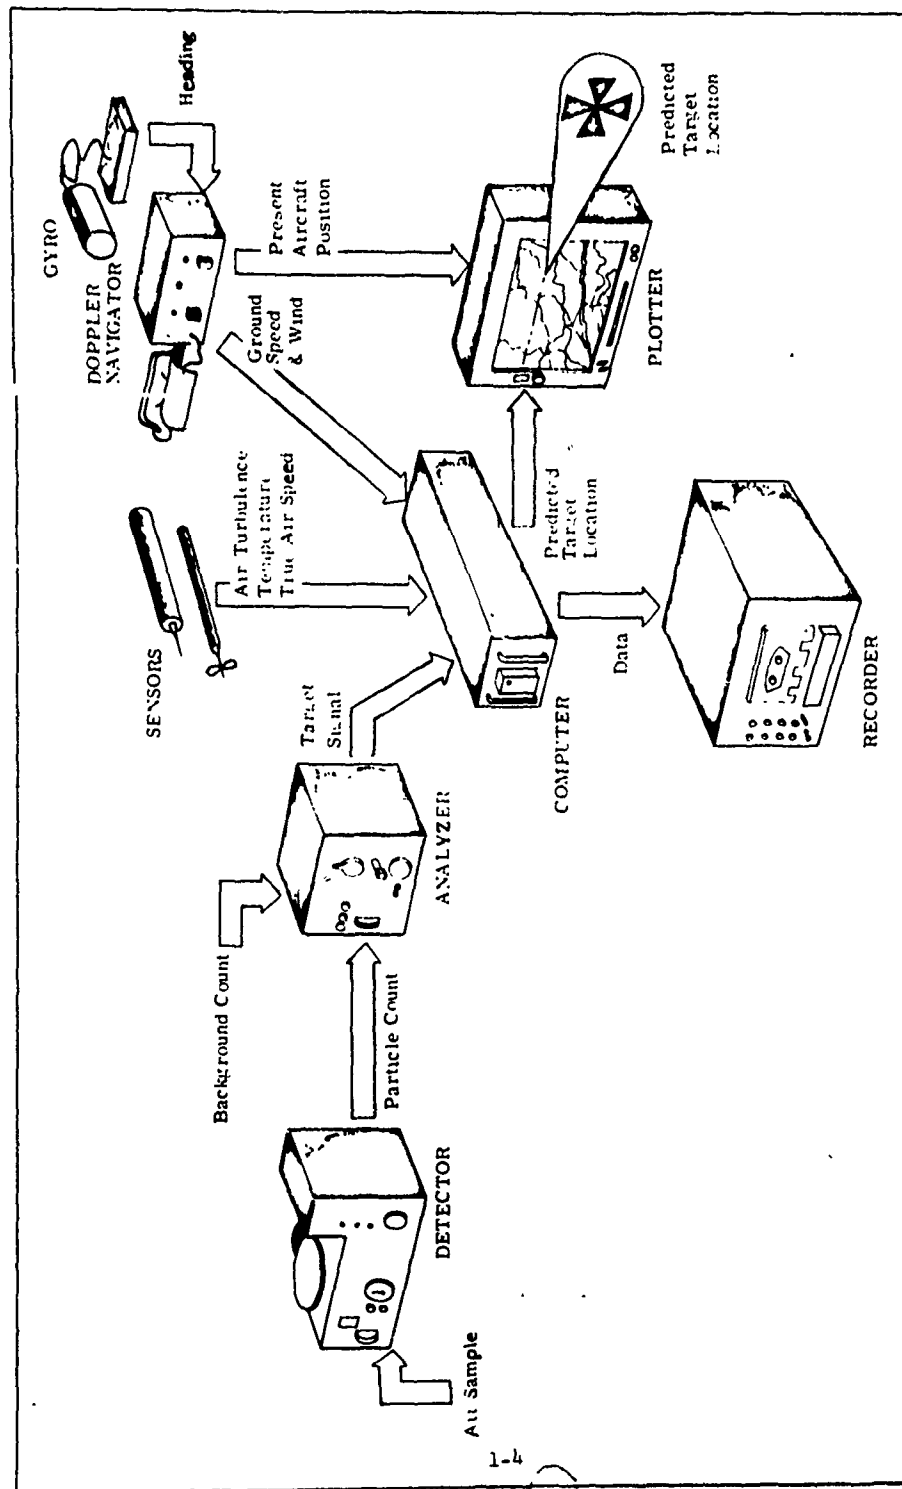
Figure 1-2. Functional Organization of AMPD-224.

The relationship of the various components in the AMPD system is shown in figure 1-2 in block diagram form.

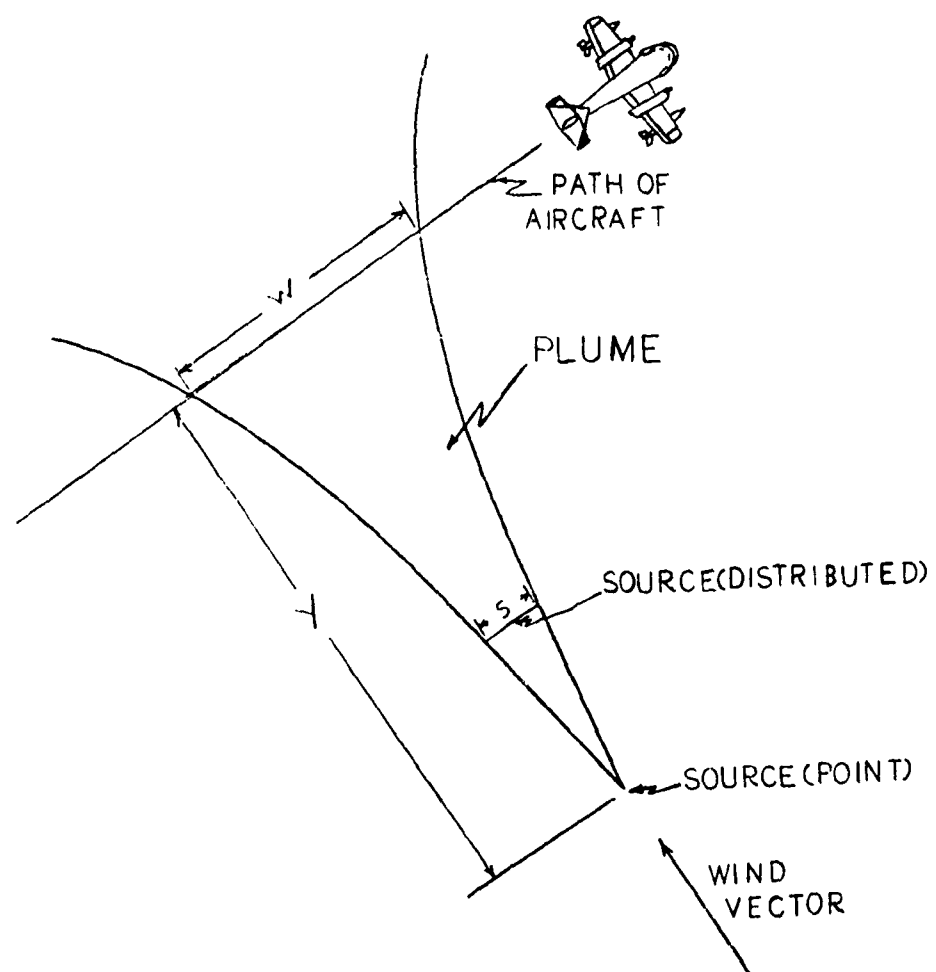
Figure 1-3. AMPD-224 System Function.

Following is an overall look at total 224 AMPD system function (see figure 1-3). A source of CN or convertibles is released into the atmosphere and diffused by the wind in a predictable manner. The resultant plume (shown two-dimensionally in figure 1-3) is carried downwind and fans out symmetrically about the wind vector. Given a constant wind and constant meteorological conditions, this pattern will hold waiting for the 224 AMPD system to fly through it.

The aircraft will fly a grid pattern in the surveillance area as nearly orthogonal as possible to the wind vector. Each leg or pass will be upwind at least 1500 meters of the last pass. Considering the last pass only (figure 1-3), it can be seen that the aircraft has flown through the plume and will have made detections (either CN or convertible) for a distance, W, determined by multiplying the average velocity from the navigational subsystem by the time in plume calculated by the Mk XII Computer with inputs from the chemical subsystem.

The distance Y is translated into map coordinates, and the plotter is commanded to mark the source location on the map, while the source location readout is commanded to display these coordinates. This source is a point source as indicated in figure 1-3.

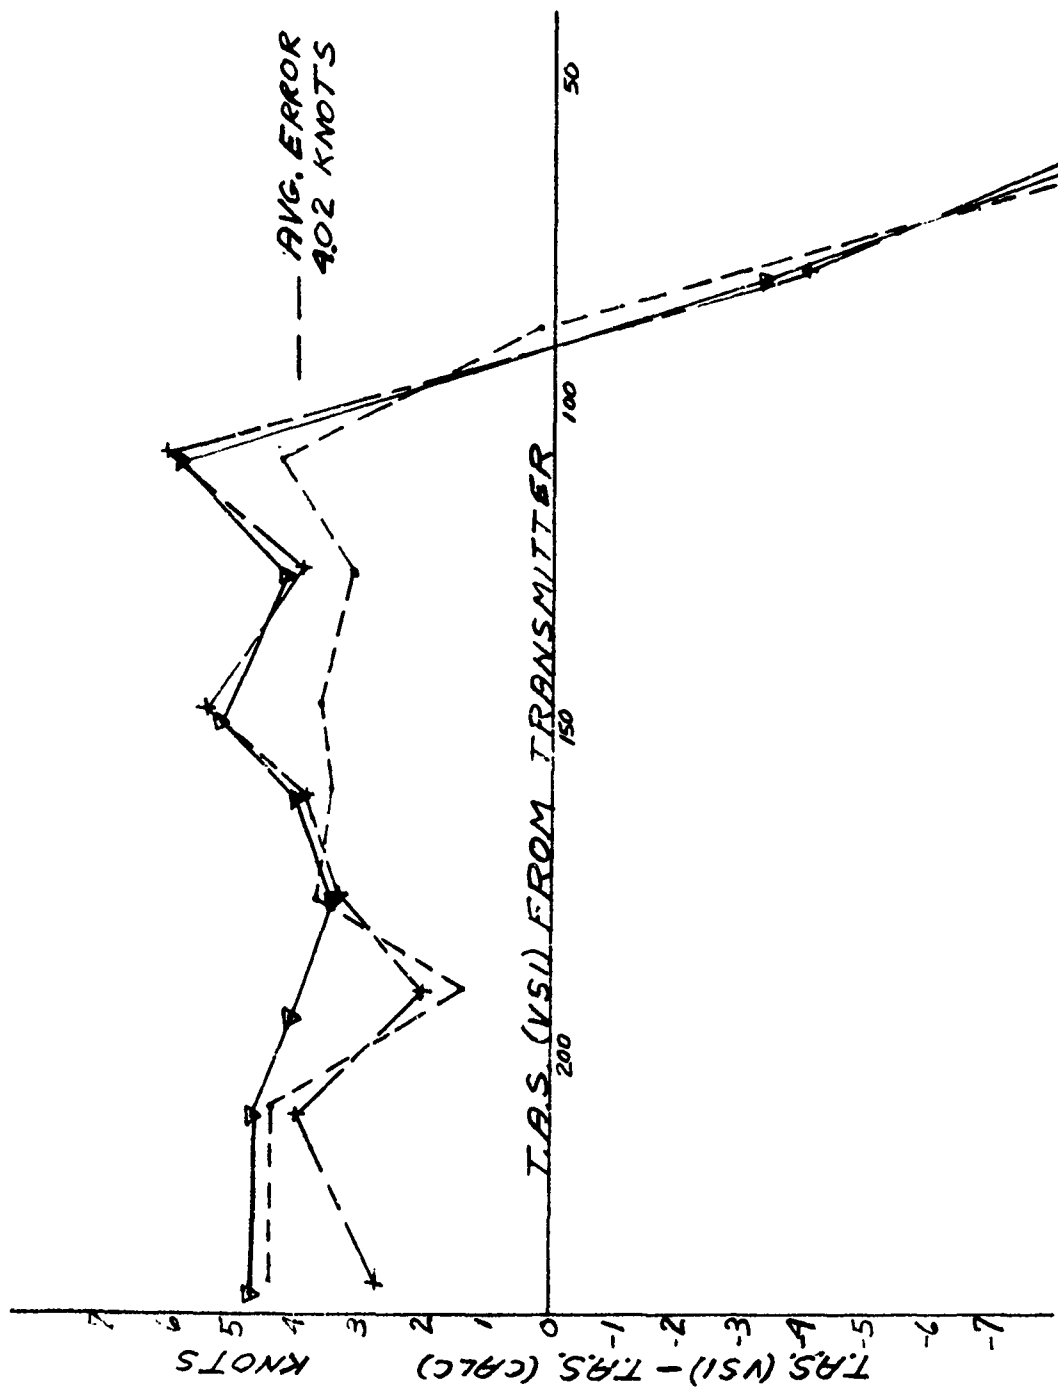
Figure 2-2. TAS Transmitter No. 1 With Pitot Tube.

The recorded TAS was compared to the calculated TAS for the corresponding pitot pressure, static pressure and temperature. The recorded TAS and error are plotted in figures 2-2 and 2-3 and the results are summarized as follows.

1. TRANSMITTER No. 1

- a. No hysteresis effect was shown measuring from 50 to 250 knots compared to measuring from 250 to 50 knots.

- b. The TAS measured on the VSI agreed with that displayed on the digital display panel within +1 knot.
- c. In the range of 100 to 250 knots, the error due to the TAS transmitter was fairly constant, averaging +4.02 knots above the calculated TAS. Below 100 knots, this error changed linearly to -18 knots at 50 knots airspeed.

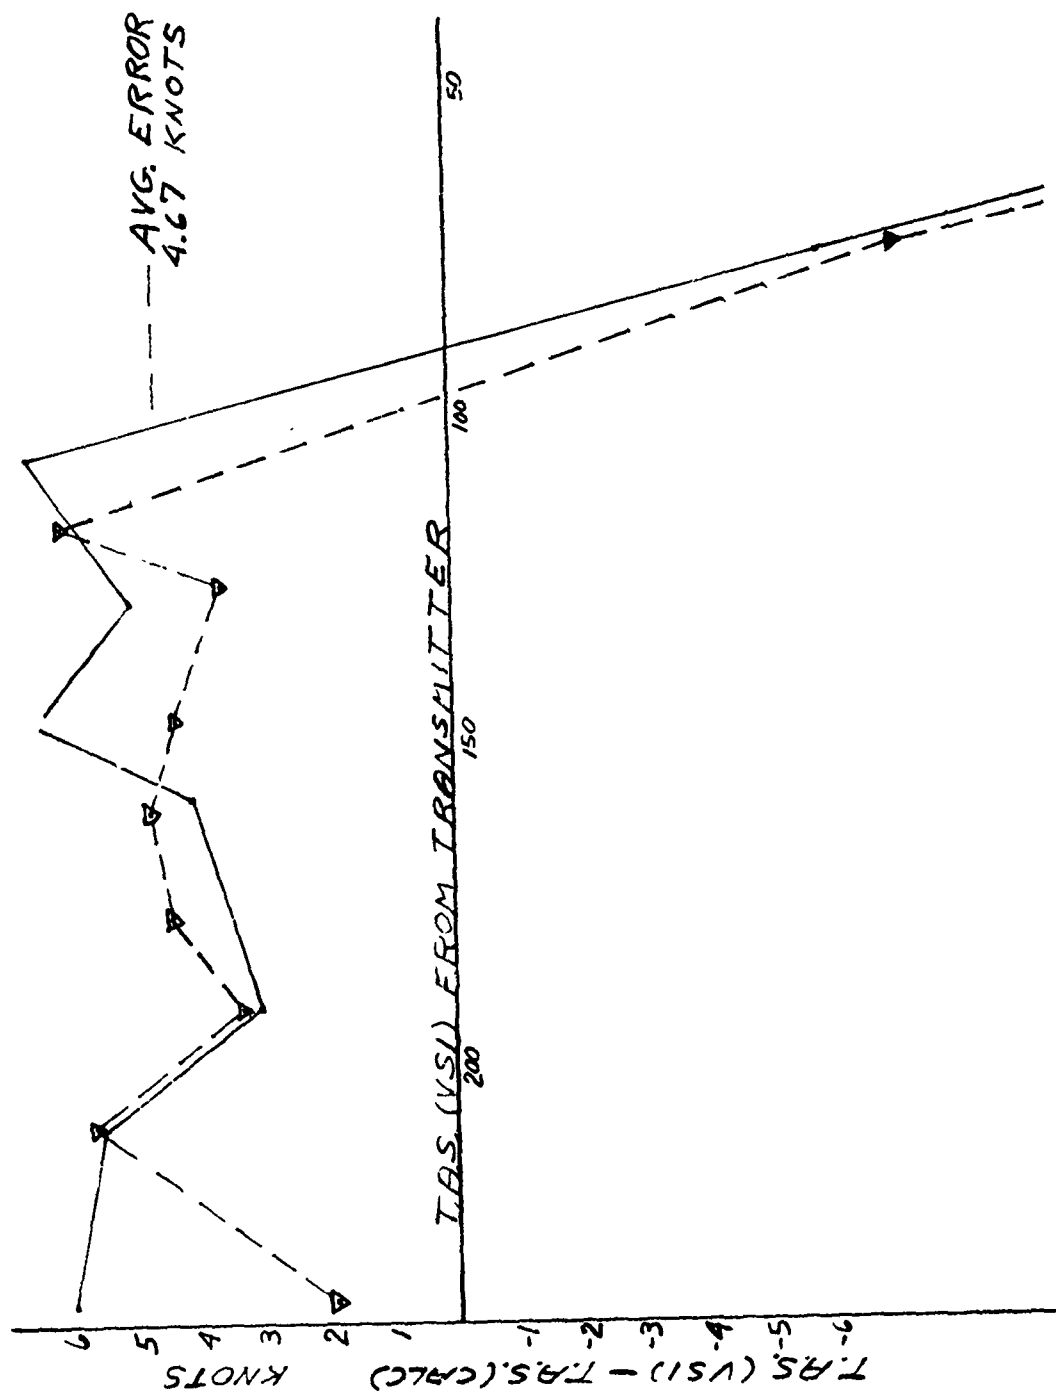
Figure 2-3. TAS Transmitter No. 2 Without Pitot Tube.

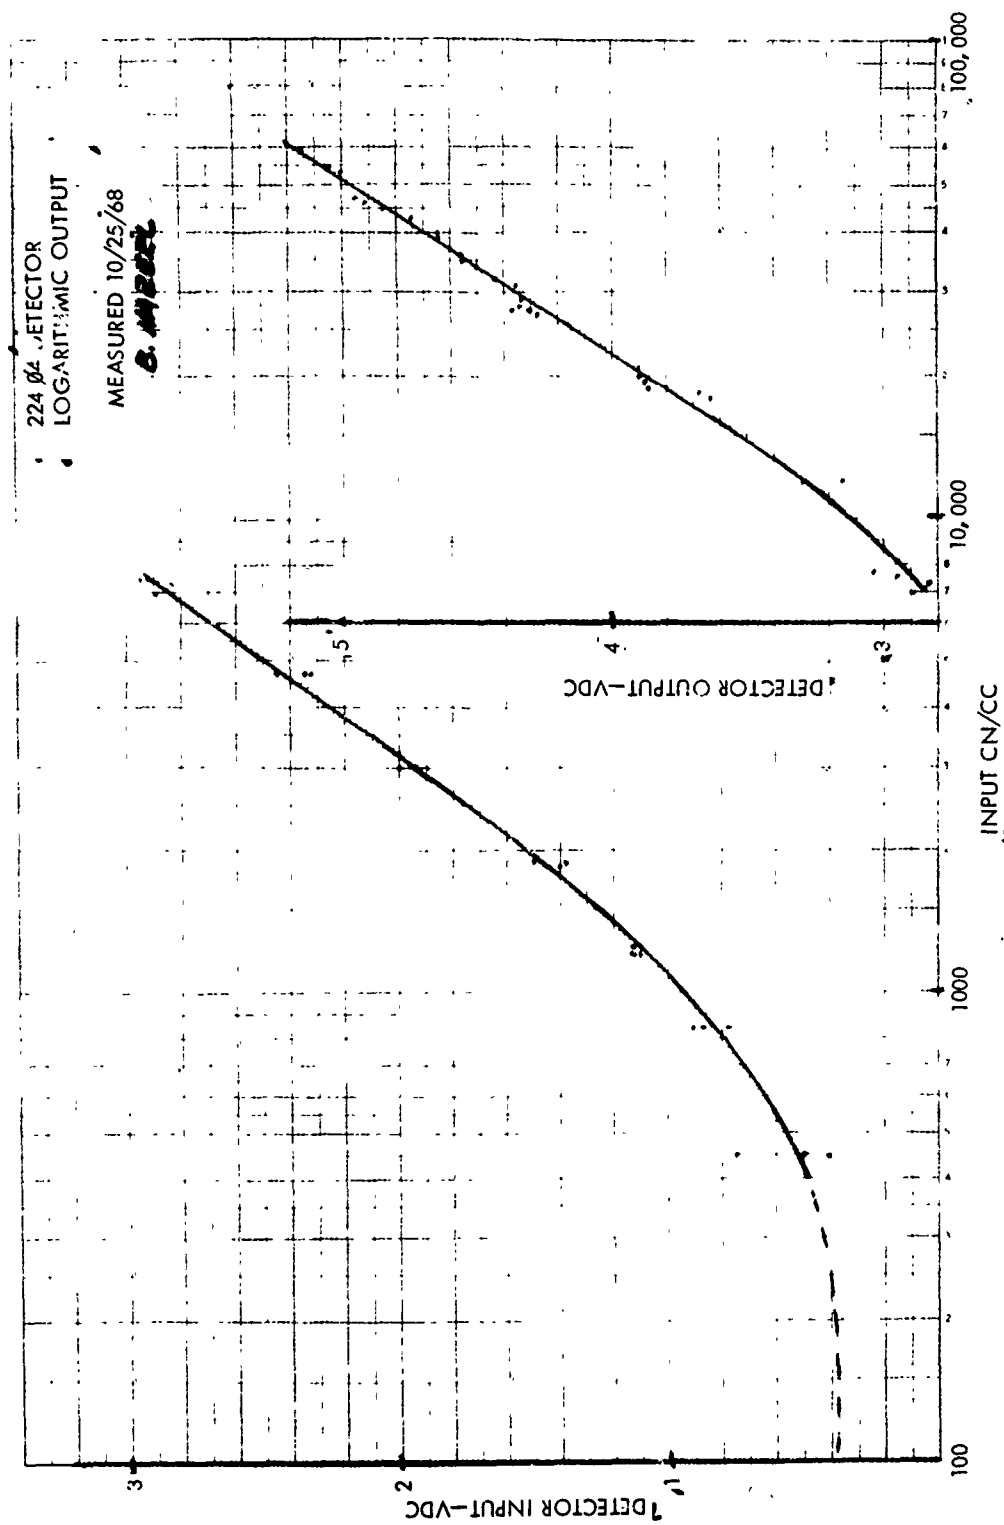
Figure 2-7. AMPD-224 Phase IV Detector Logarithmic Output.

Calibration data was measured 25 Oct 68 on three production logarithmic amplifiers installed in three AMPD-224 detectors. The data was smoothed and converted to the table (table 2-1) of digital count versus nuclei/cc. This table was to be used in the digital computer programming effort to convert detector output to nuclei/cc. The detector logarithmic output curve is shown in figure 2-7.

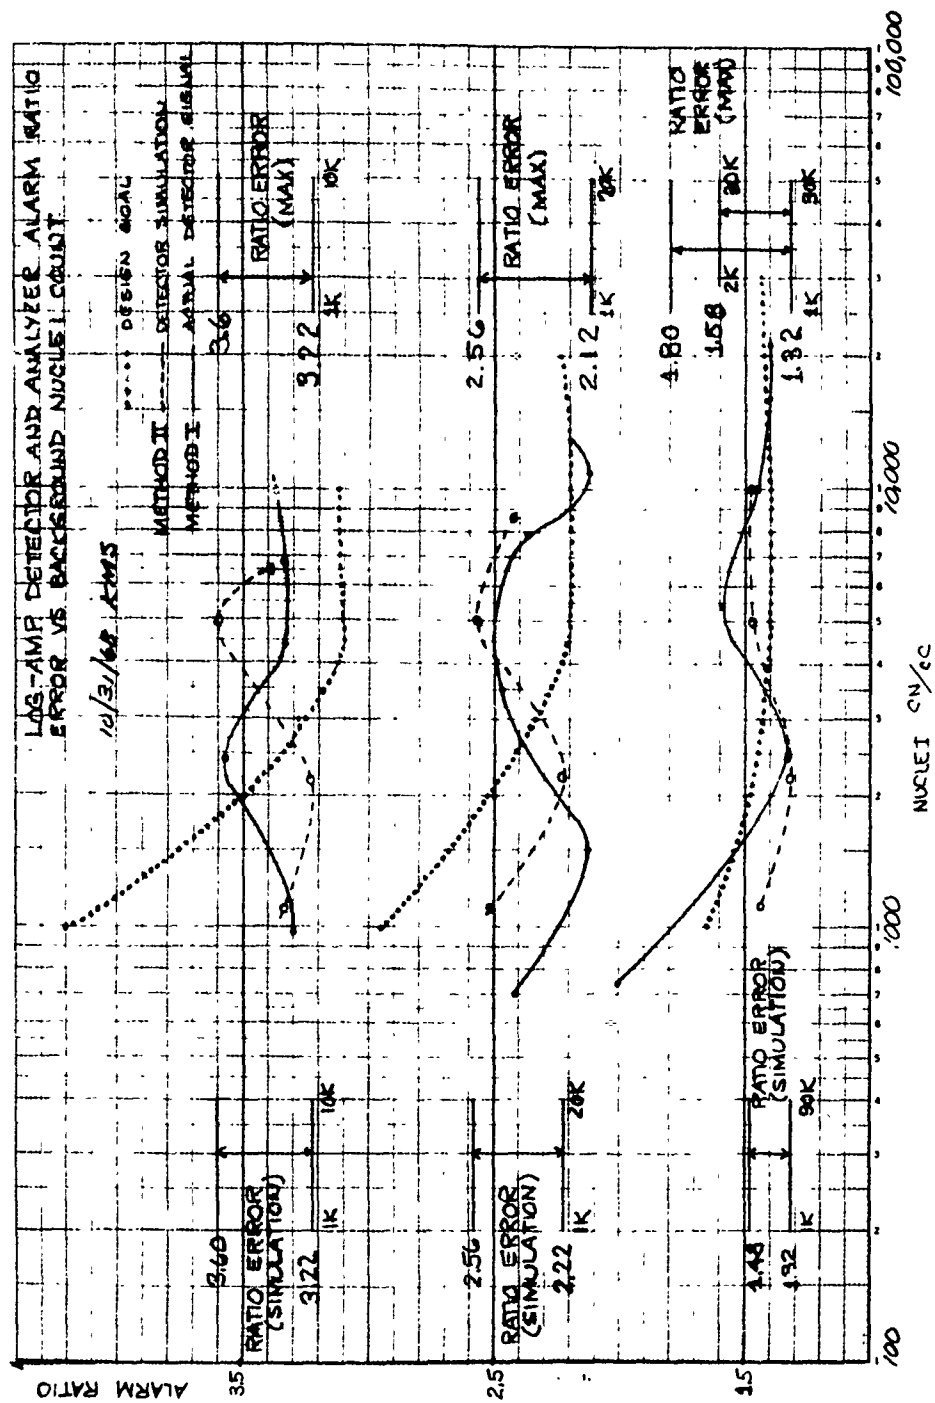
Figure 2-8. Log-Amp Detector and Analyzer Alarm Ratio Error vs Background Nuclei Count.

The log-amp modifications were checked out in the 224-AMPD System on 28 October, 1968 (figure 2-8); the results follow.

2.2.13.5.1 Ratio Error. The ratio error (figure 2-8) was evaluated in the following manner:

3. Results (figure 2-8)

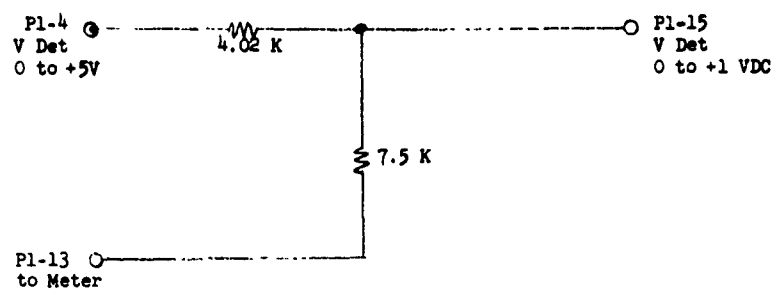
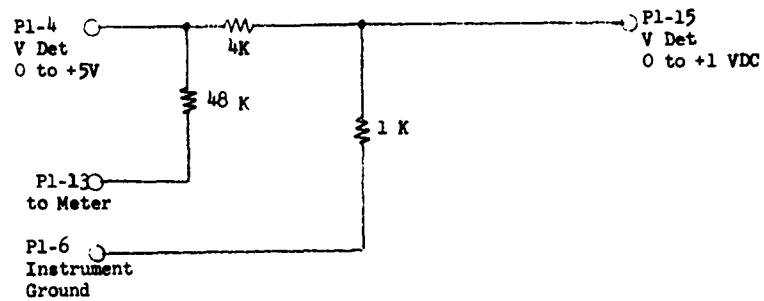
Feedback Motor Drive Module

After Change:

Figure 2-11. Modification No. 4/V Detector Before and After Change.

2.2.17.4 Modification No. 4/V Detector/V Background Final Steady State Correspondance. Figure 2-11 shows the feedback motor drive module before and after change.

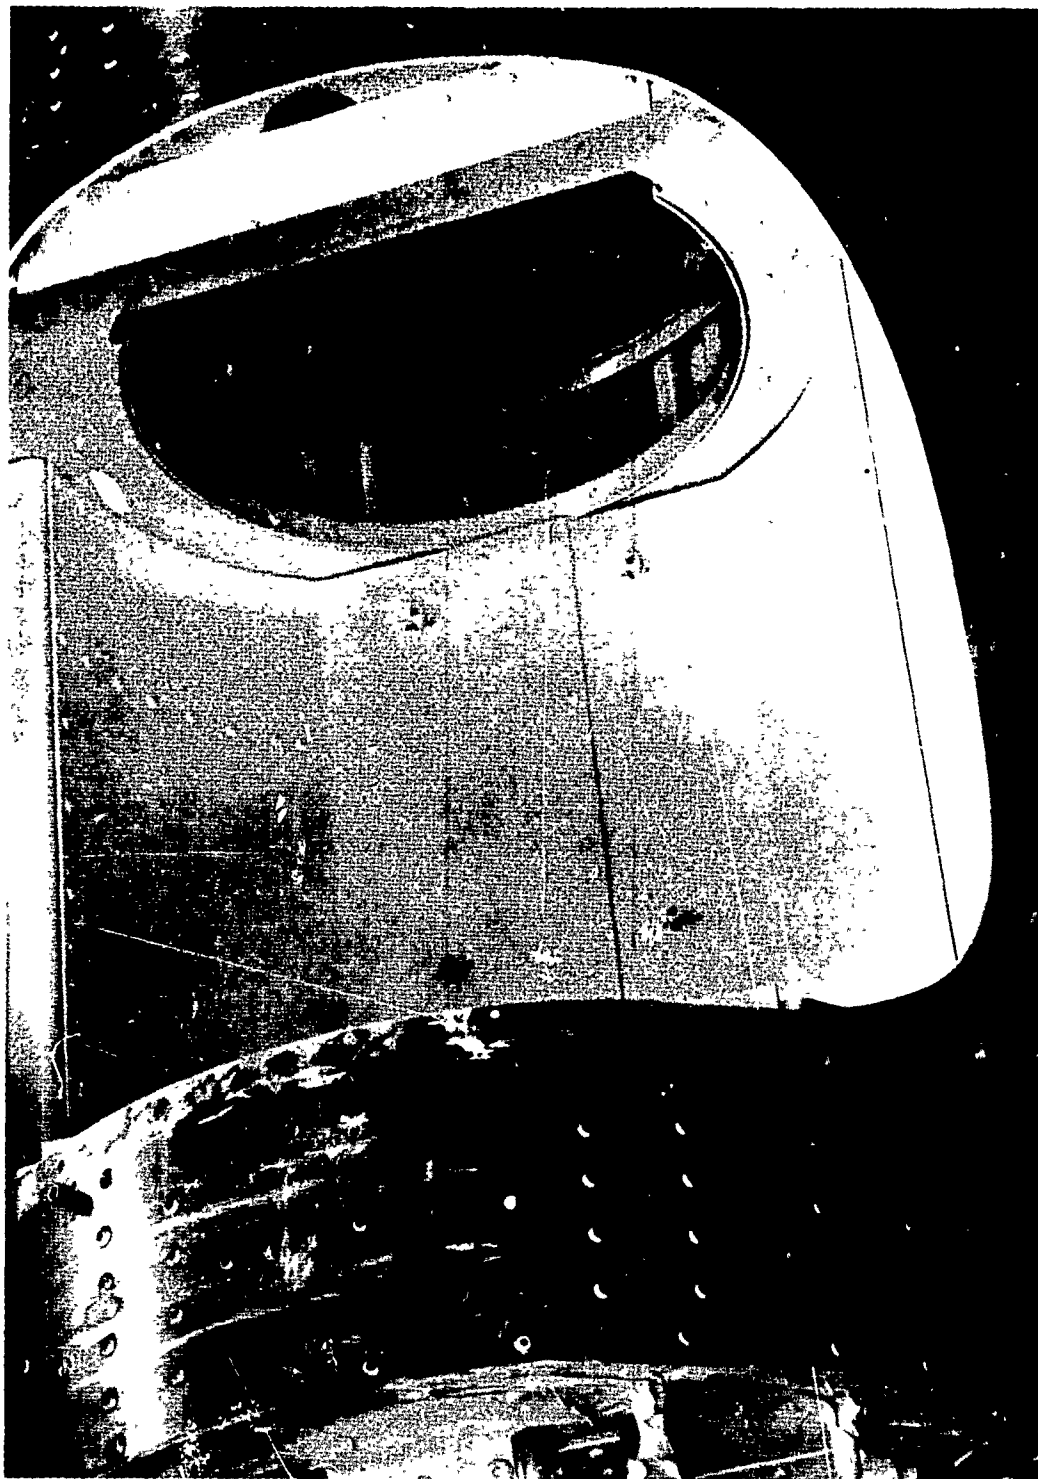
Figure 3-5. Pod 2 Center Section (Antenna Compartment).

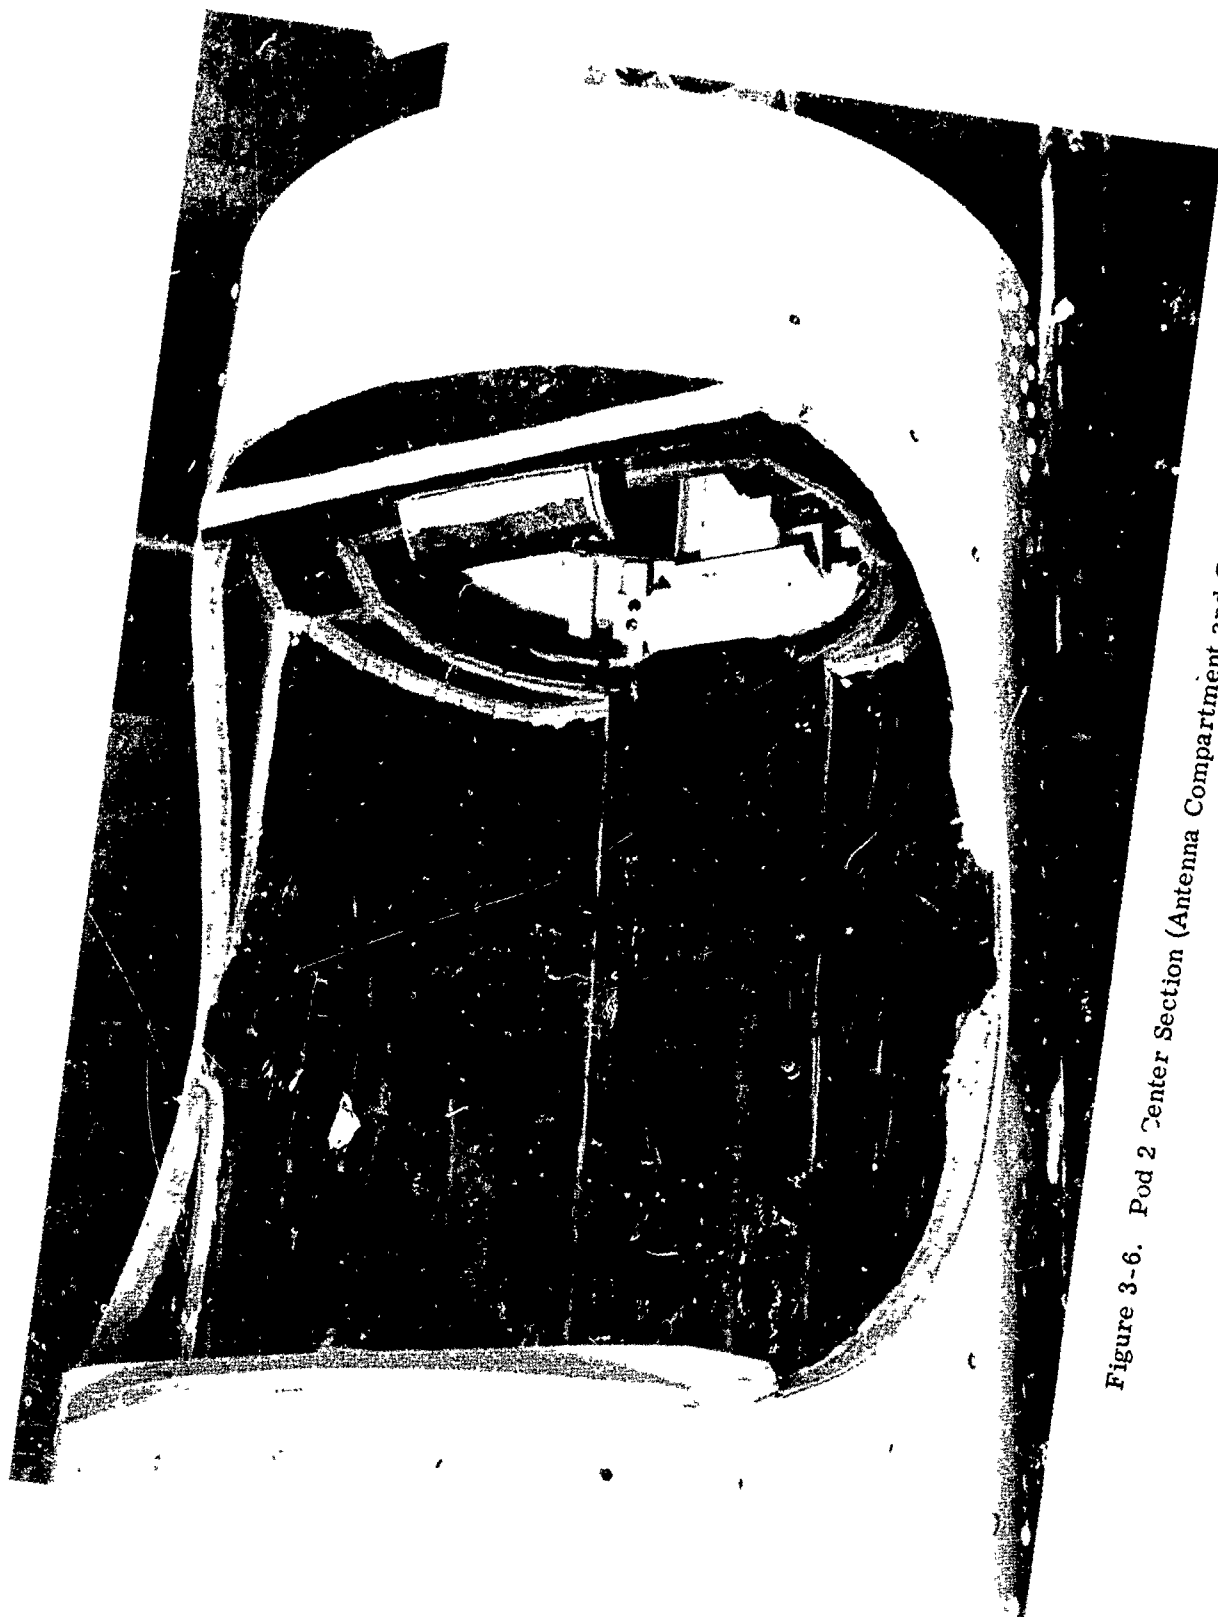
Figure 3-6. Pod 2 Center Section (Antenna Compartment and Cable Trough).

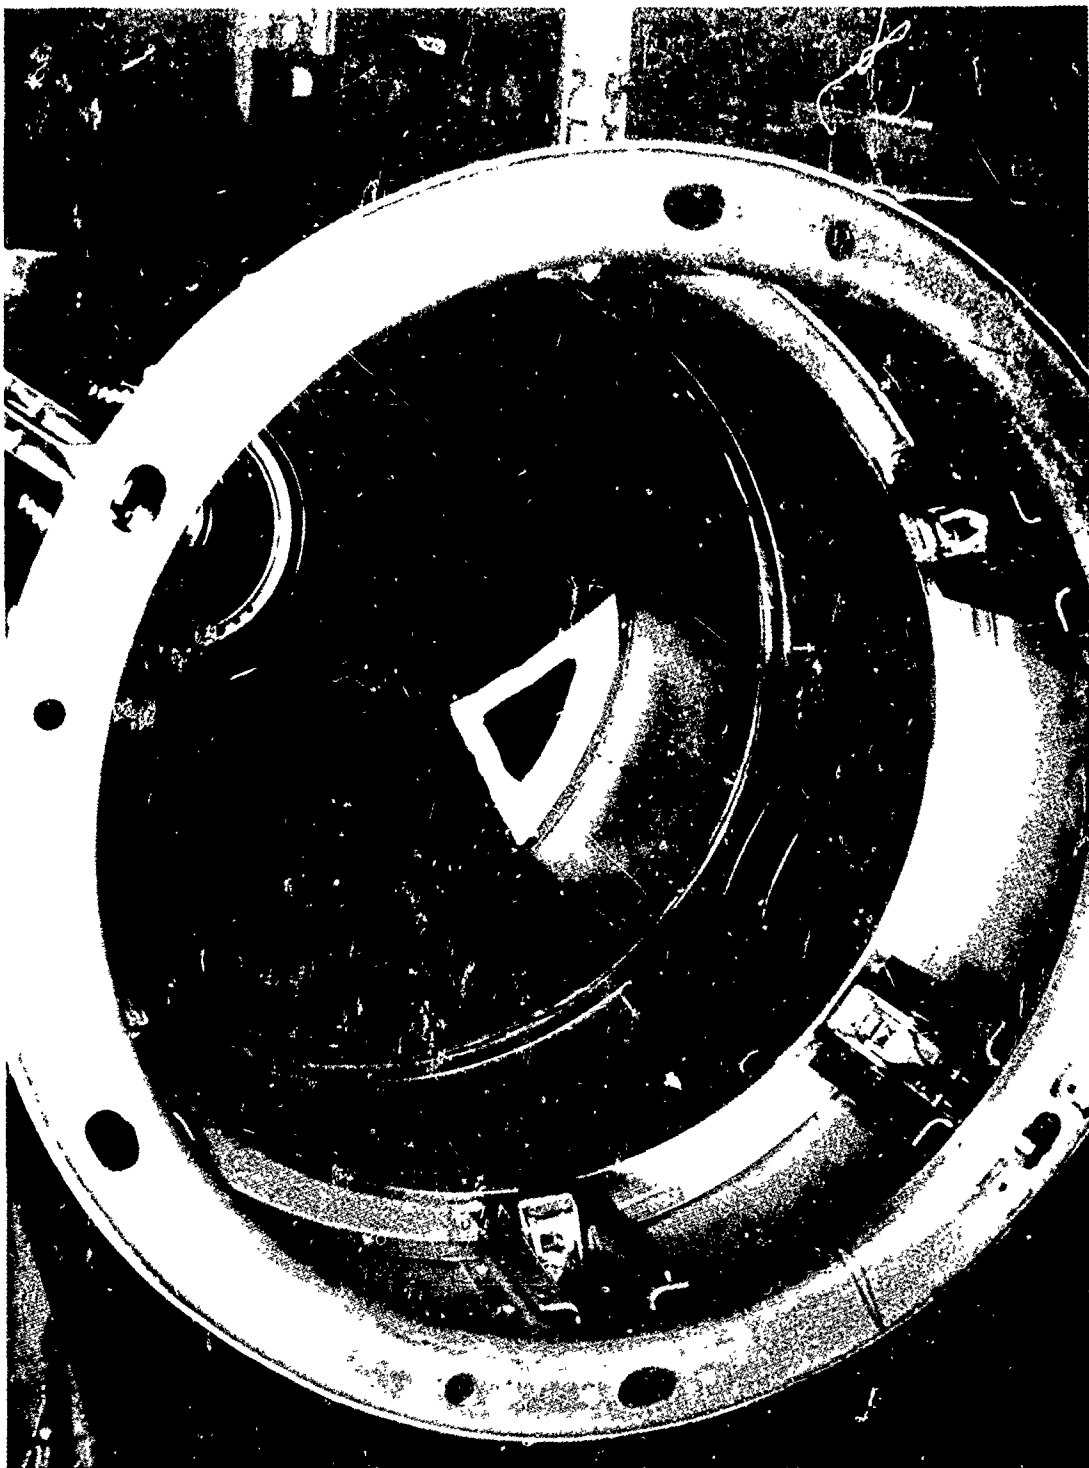
Figure 3-7. Pod 2 Forward End Section.

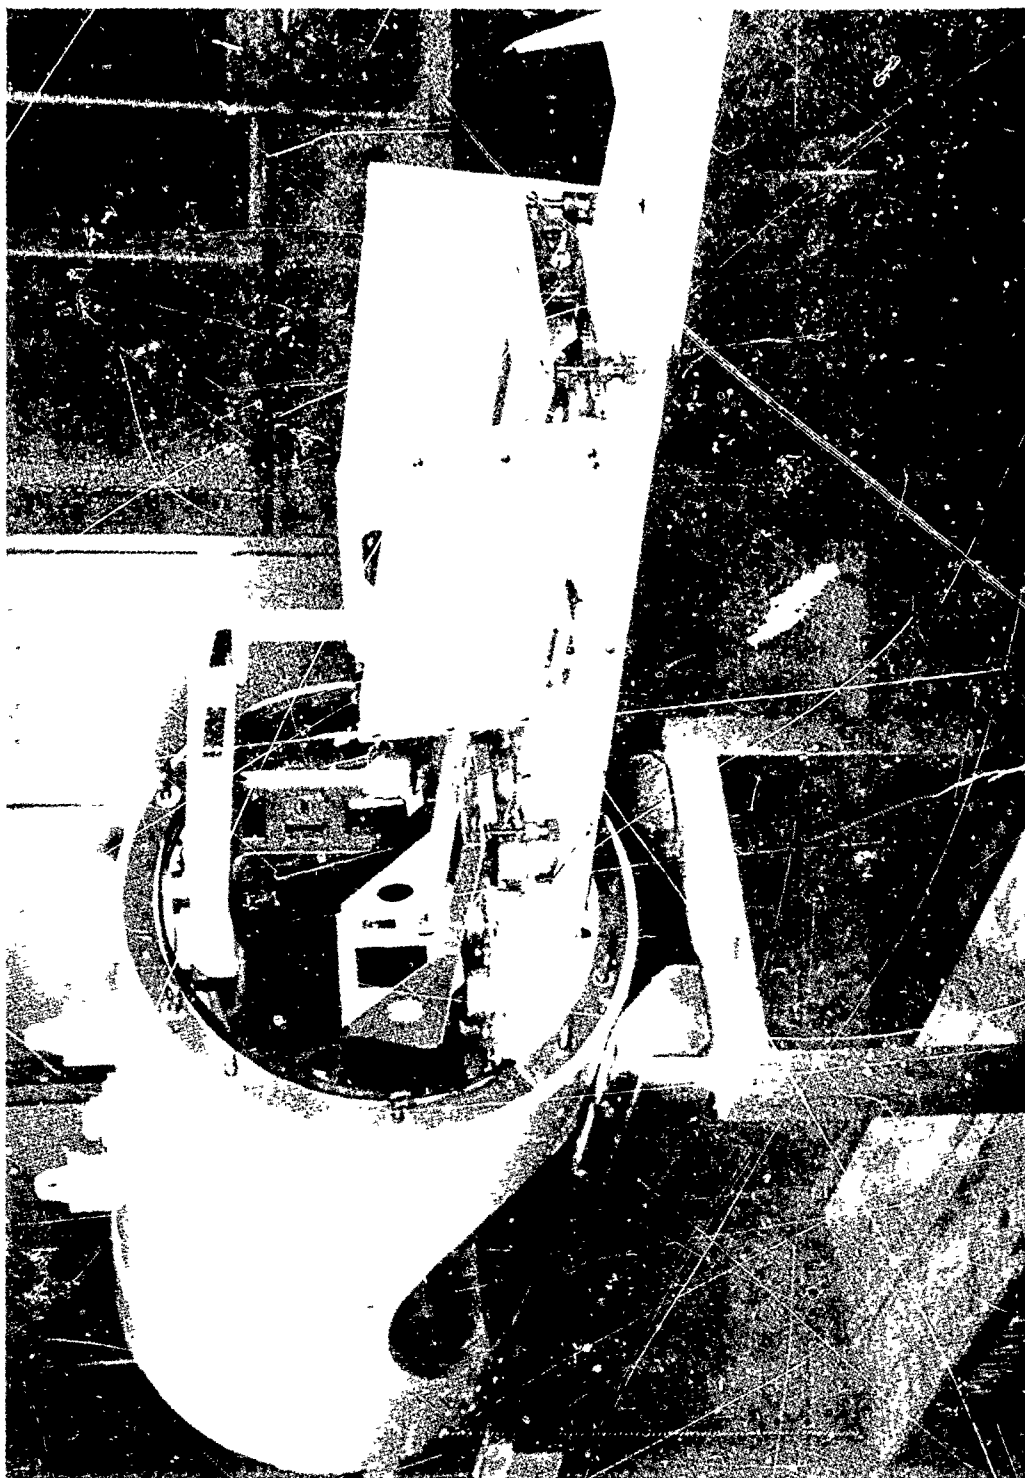
Figure 3-8. Pod 2 Aft Beam Sections With Equipment Shock Mounts Installed.

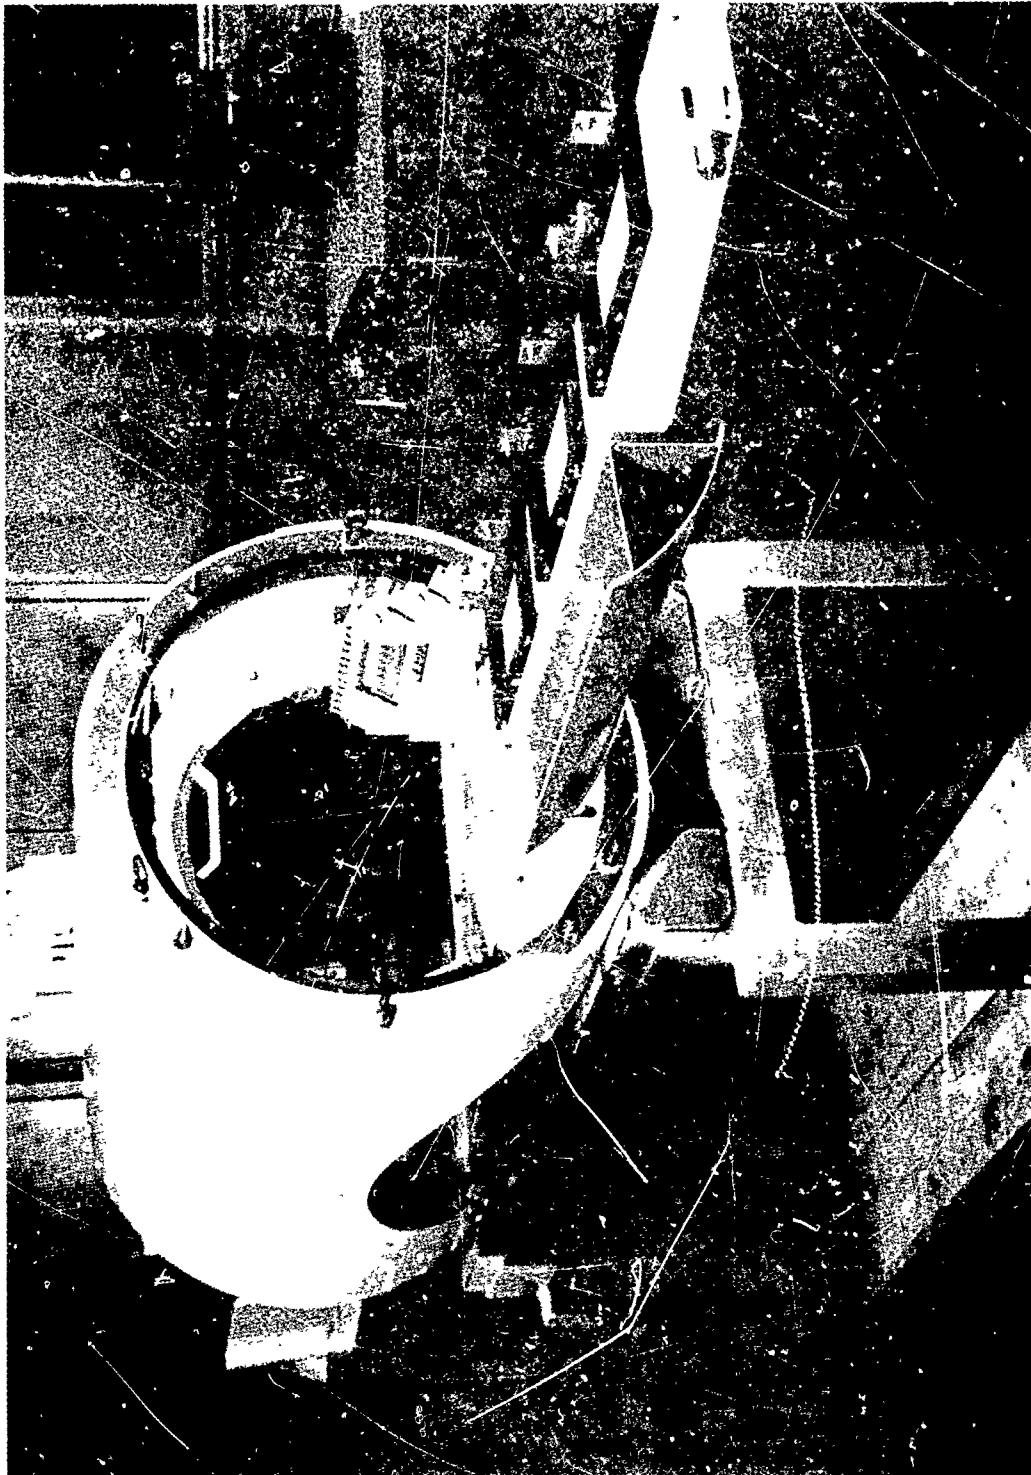
Figure 3-9. Pod 2 Forward Beam Section With Equipment Mounting Brackets Installed.

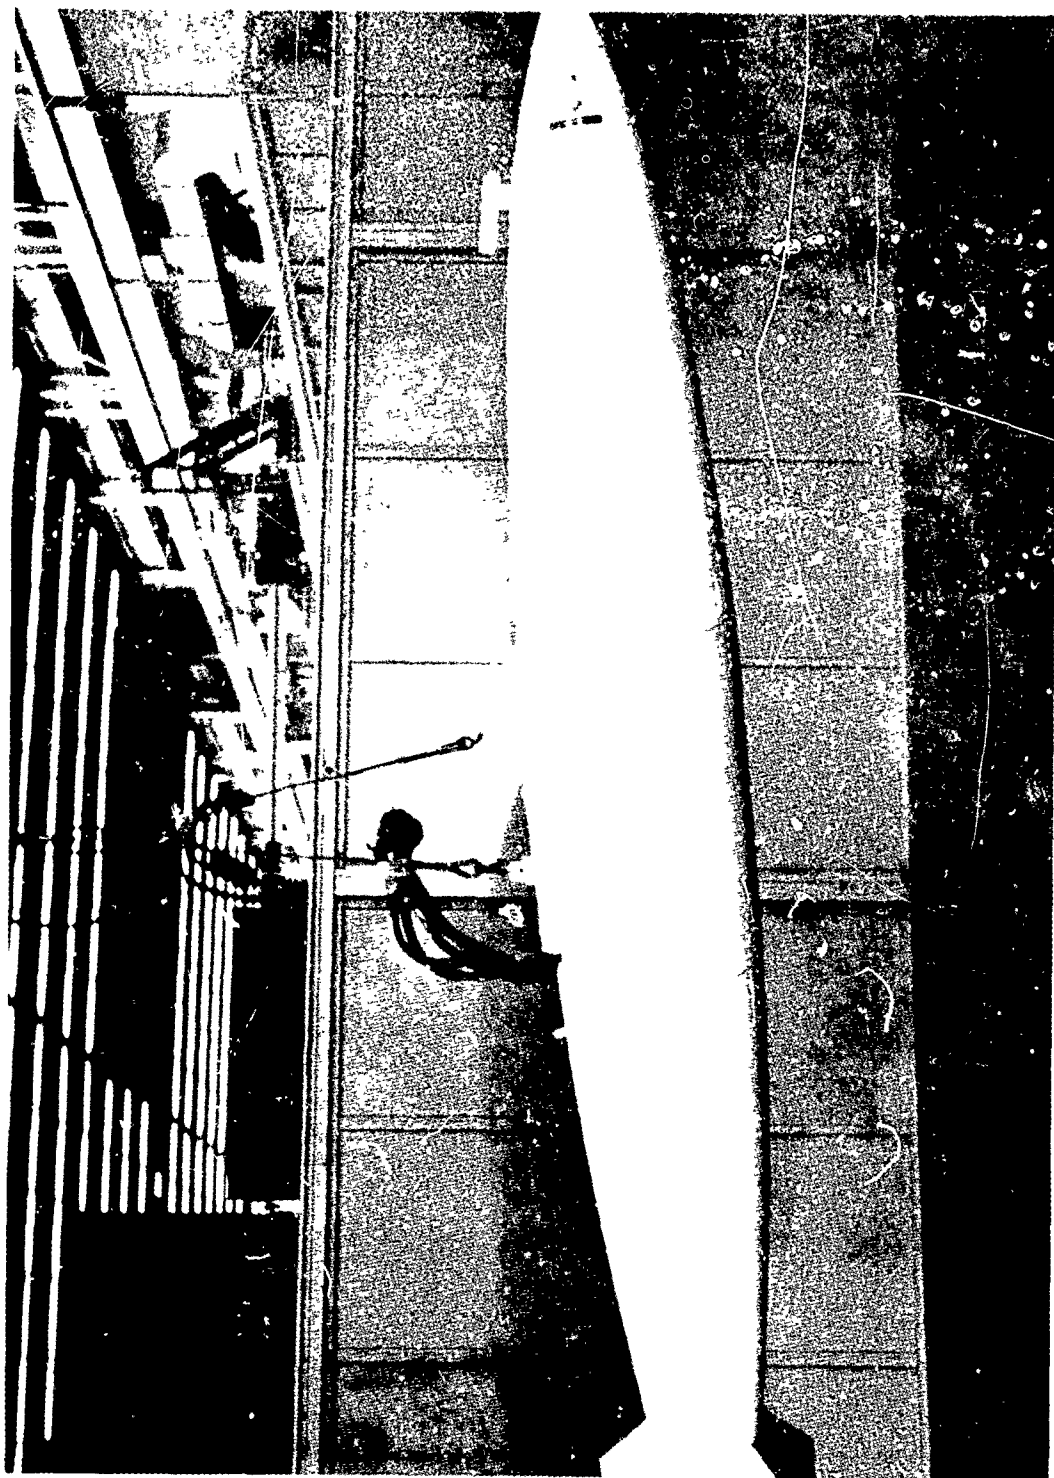
Figure 3-10. Pod 1 Weight and Center of Gravity Determination (View Right Side).

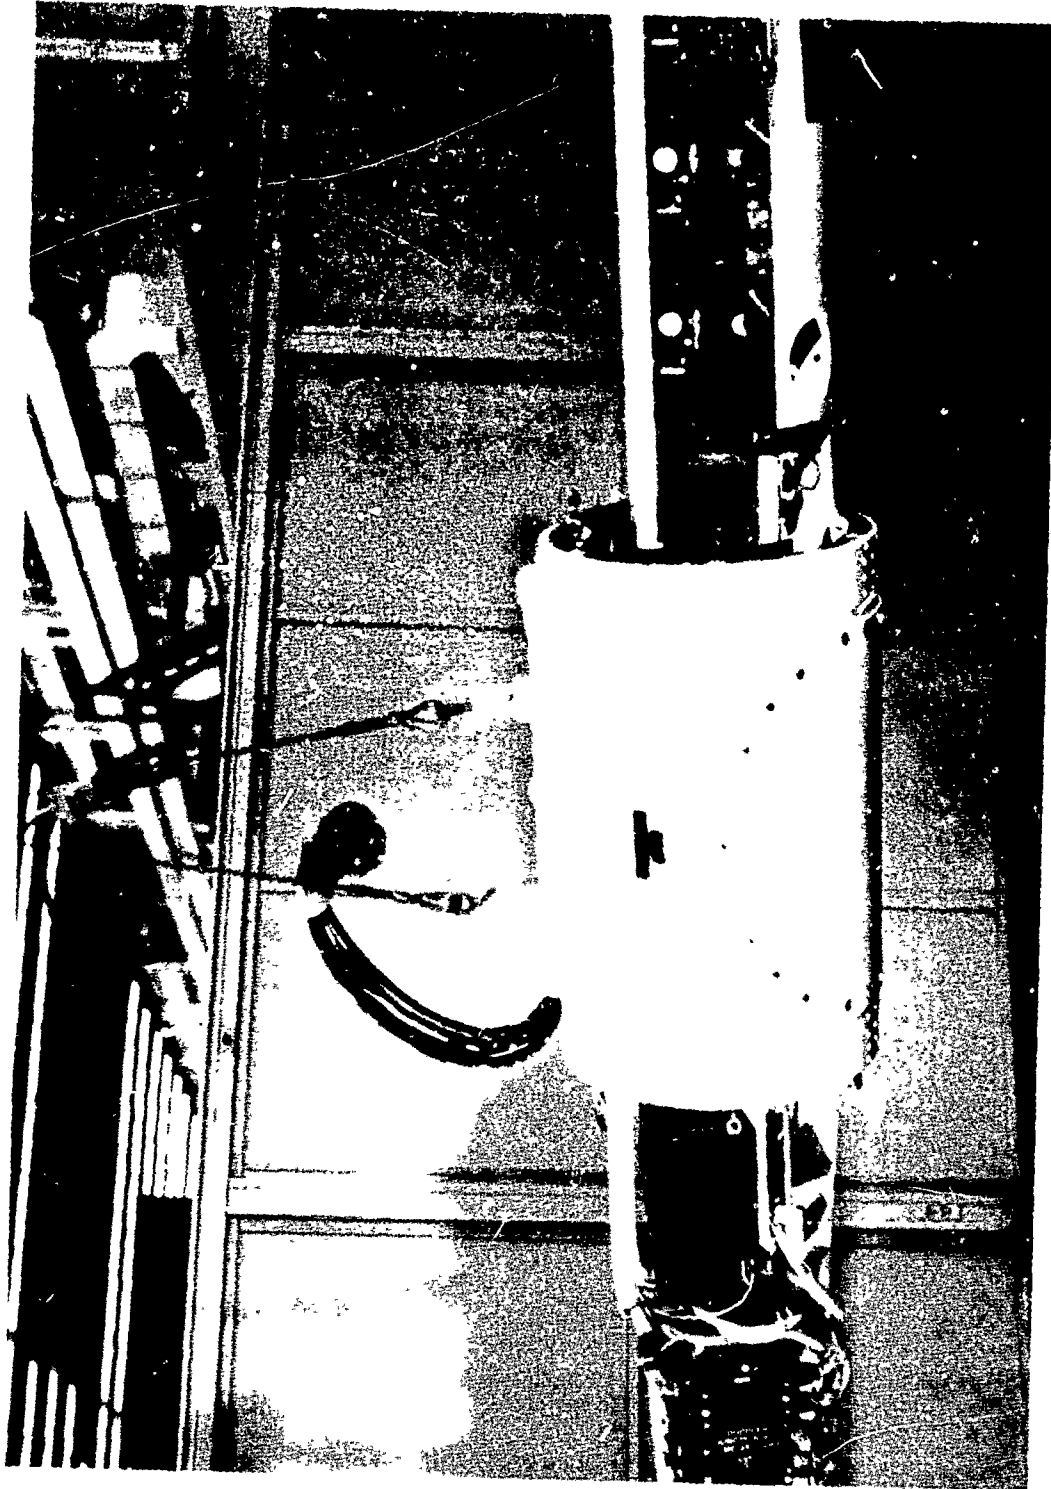
Figure 3-11. Pod 2 Weight and Center of Gravity Determination End Sections Removed (View Right Side).
